TS-AMD-85741
October 1985

HISTORICAL AERIAL PHOTOGRAPHIC ANALYSIS OF WOOD TREATMENT FACILITIES

Montana

W. M. Mack
Environmental Programs
Lockheed Engineering and Management Services Company, Inc.
Las Vegas, Nevada 89114

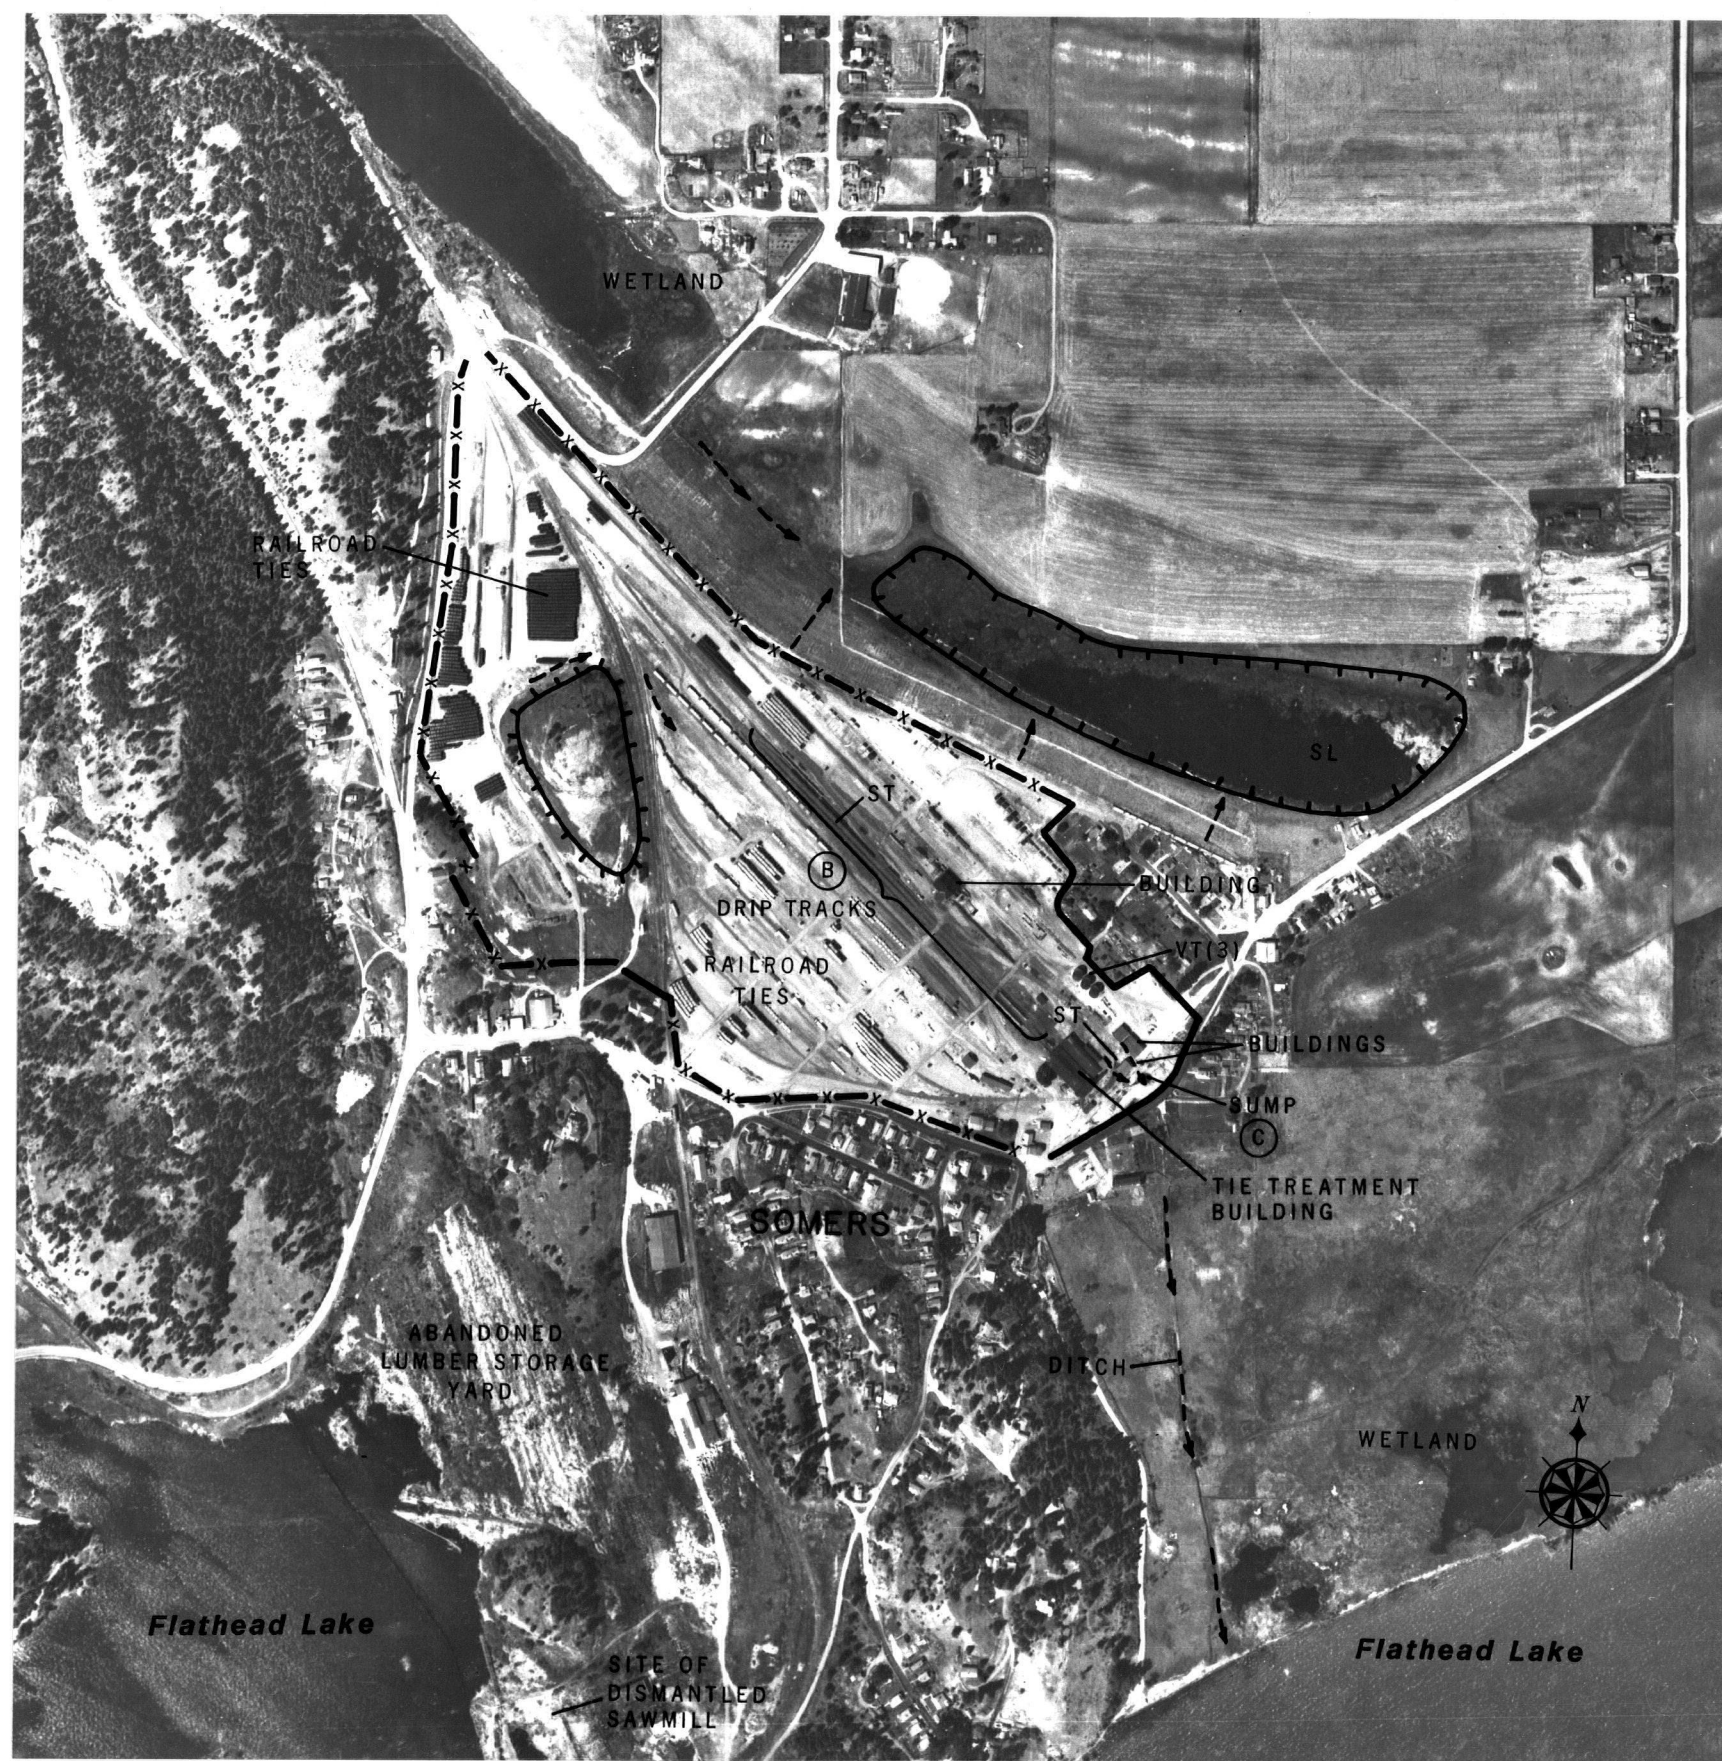
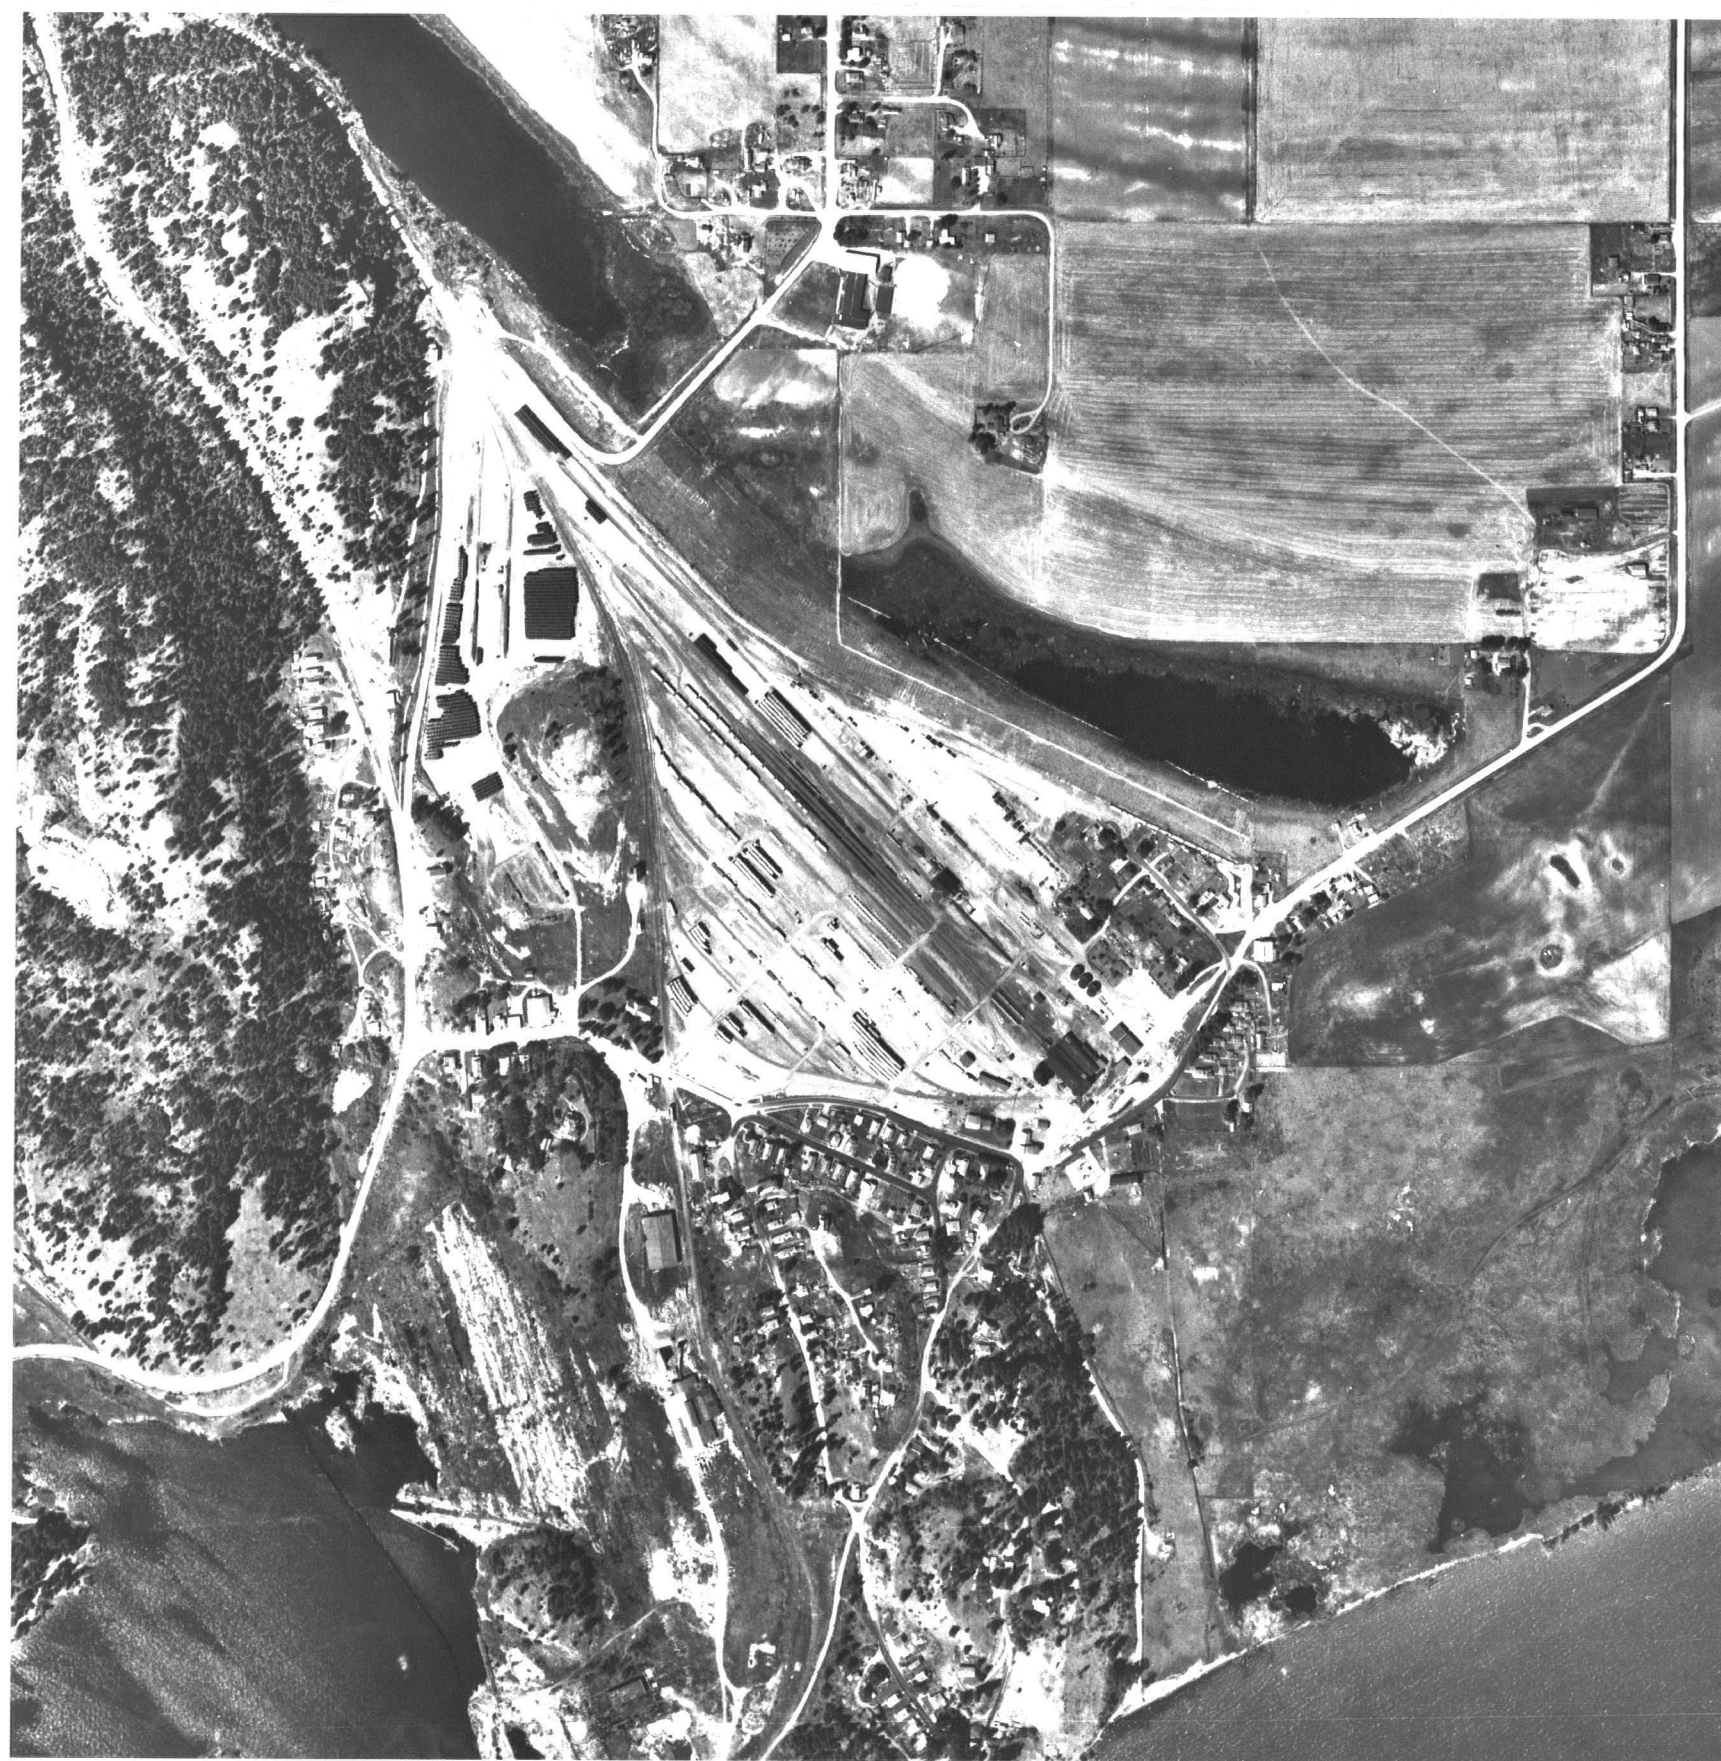
Figure 6. Burlington Northern Railroad, Somers Tie Treatment Plant, July 1, 1961.
Approximate scale 1:7,200.

The drip tracks (annotation "B") appear to be in a low area of the site; consequently, spillage along these tracks appears generally contained onsite. The sump pit (annotation "C") at the southeast end of the tie treatment building receives spillage from the tie treatment plant as indicated by visible ground stains. There are no discernable indications of vegetation stress at this facility.

The adjacent sawmill southwest of this tie treatment plant is dismantled and the abandoned lumber storage yard is overgrown by vegetation.

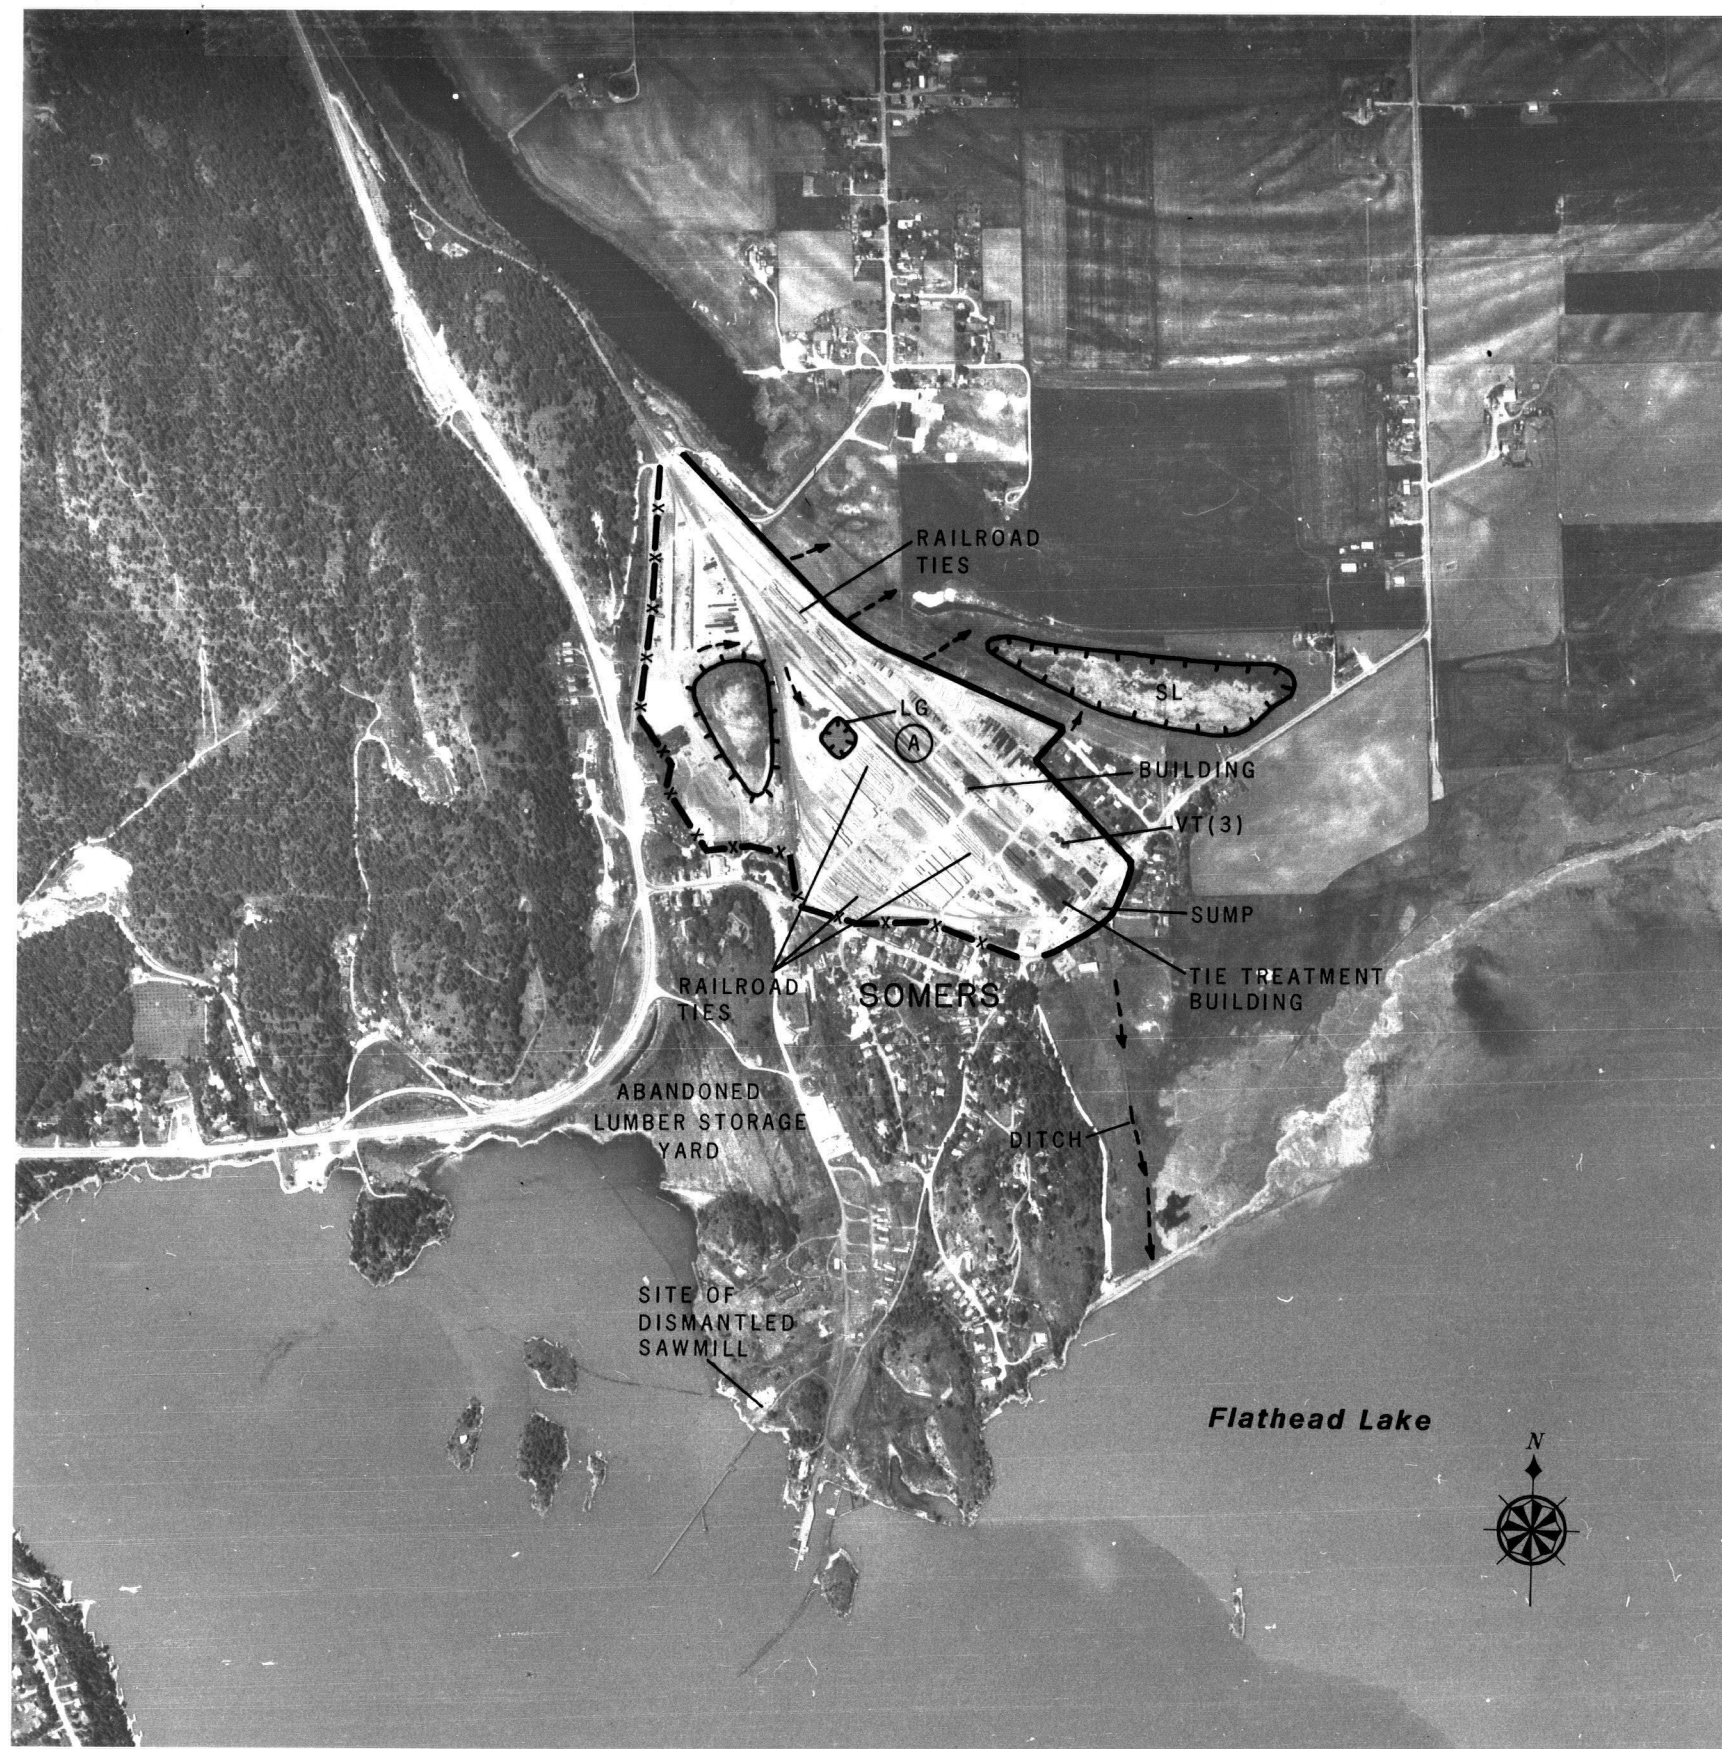
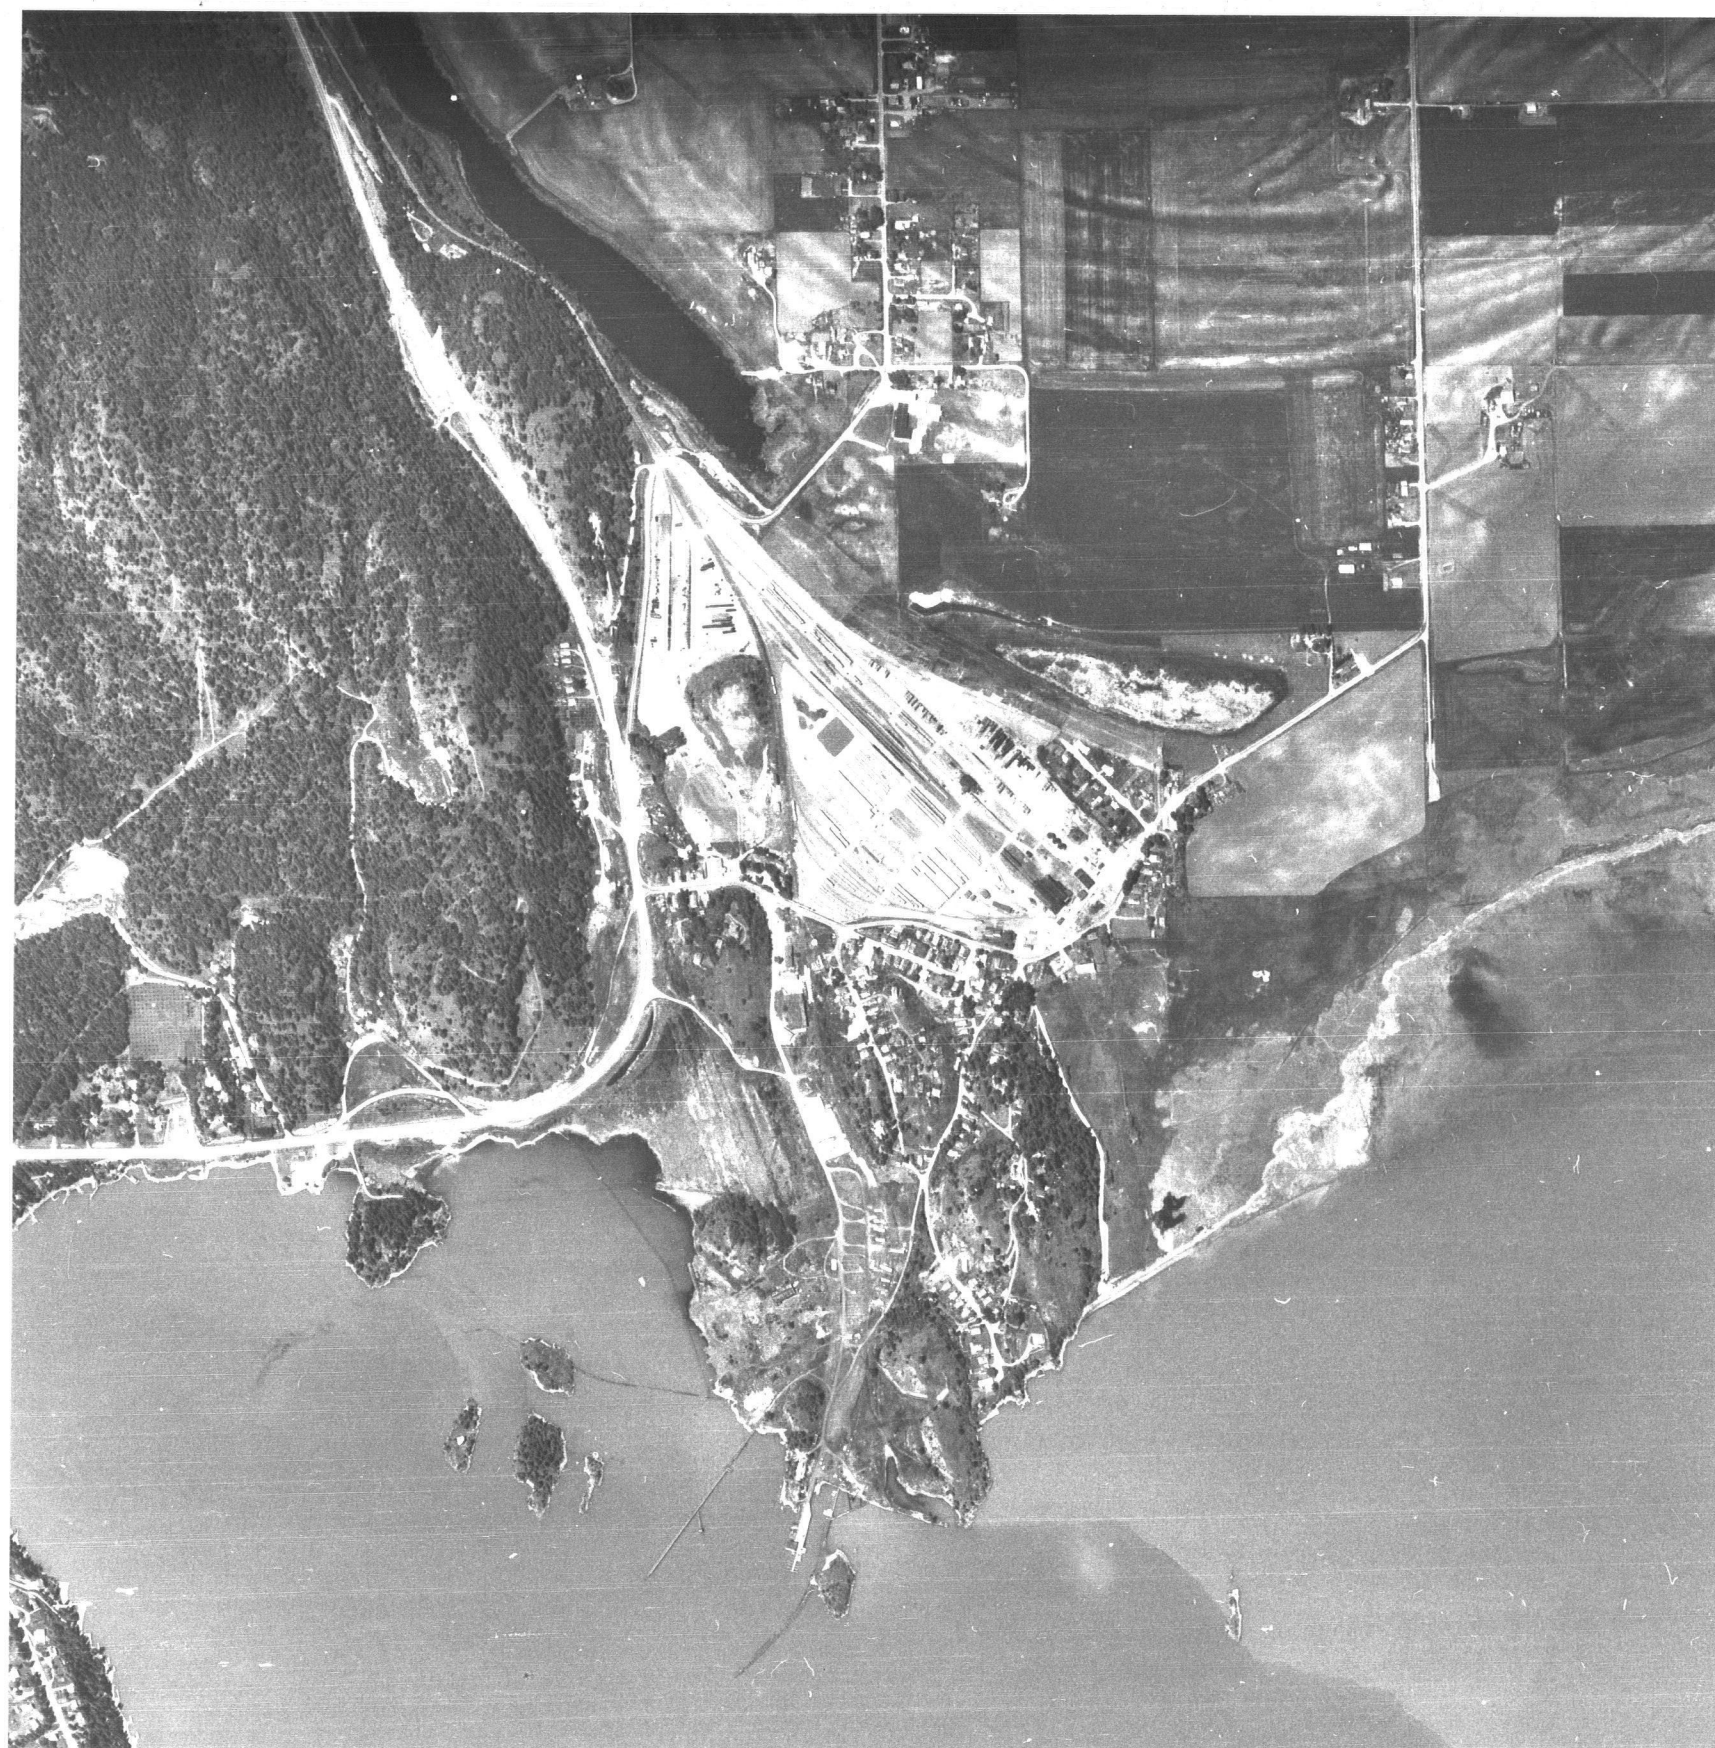
Figure 7. Burlington Northern Railroad, Somers Tie Treatment Plant, June 14, 1974.
Approximate scale 1:11,500.

The 1974 photograph (Figure 7) shows an active wood treatment facility not changed significantly since 1961 (Figure 6). A waste lagoon containing liquid (annotation "A") is not^W present near the center of the facility.

The oxbow lake adjacent to the site's northeast corner appears to support wetland vegetation; it continues to collect a portion of the runoff from the tie treatment facility. There are no discernable indications of leachate or vegetation stress at this facility.

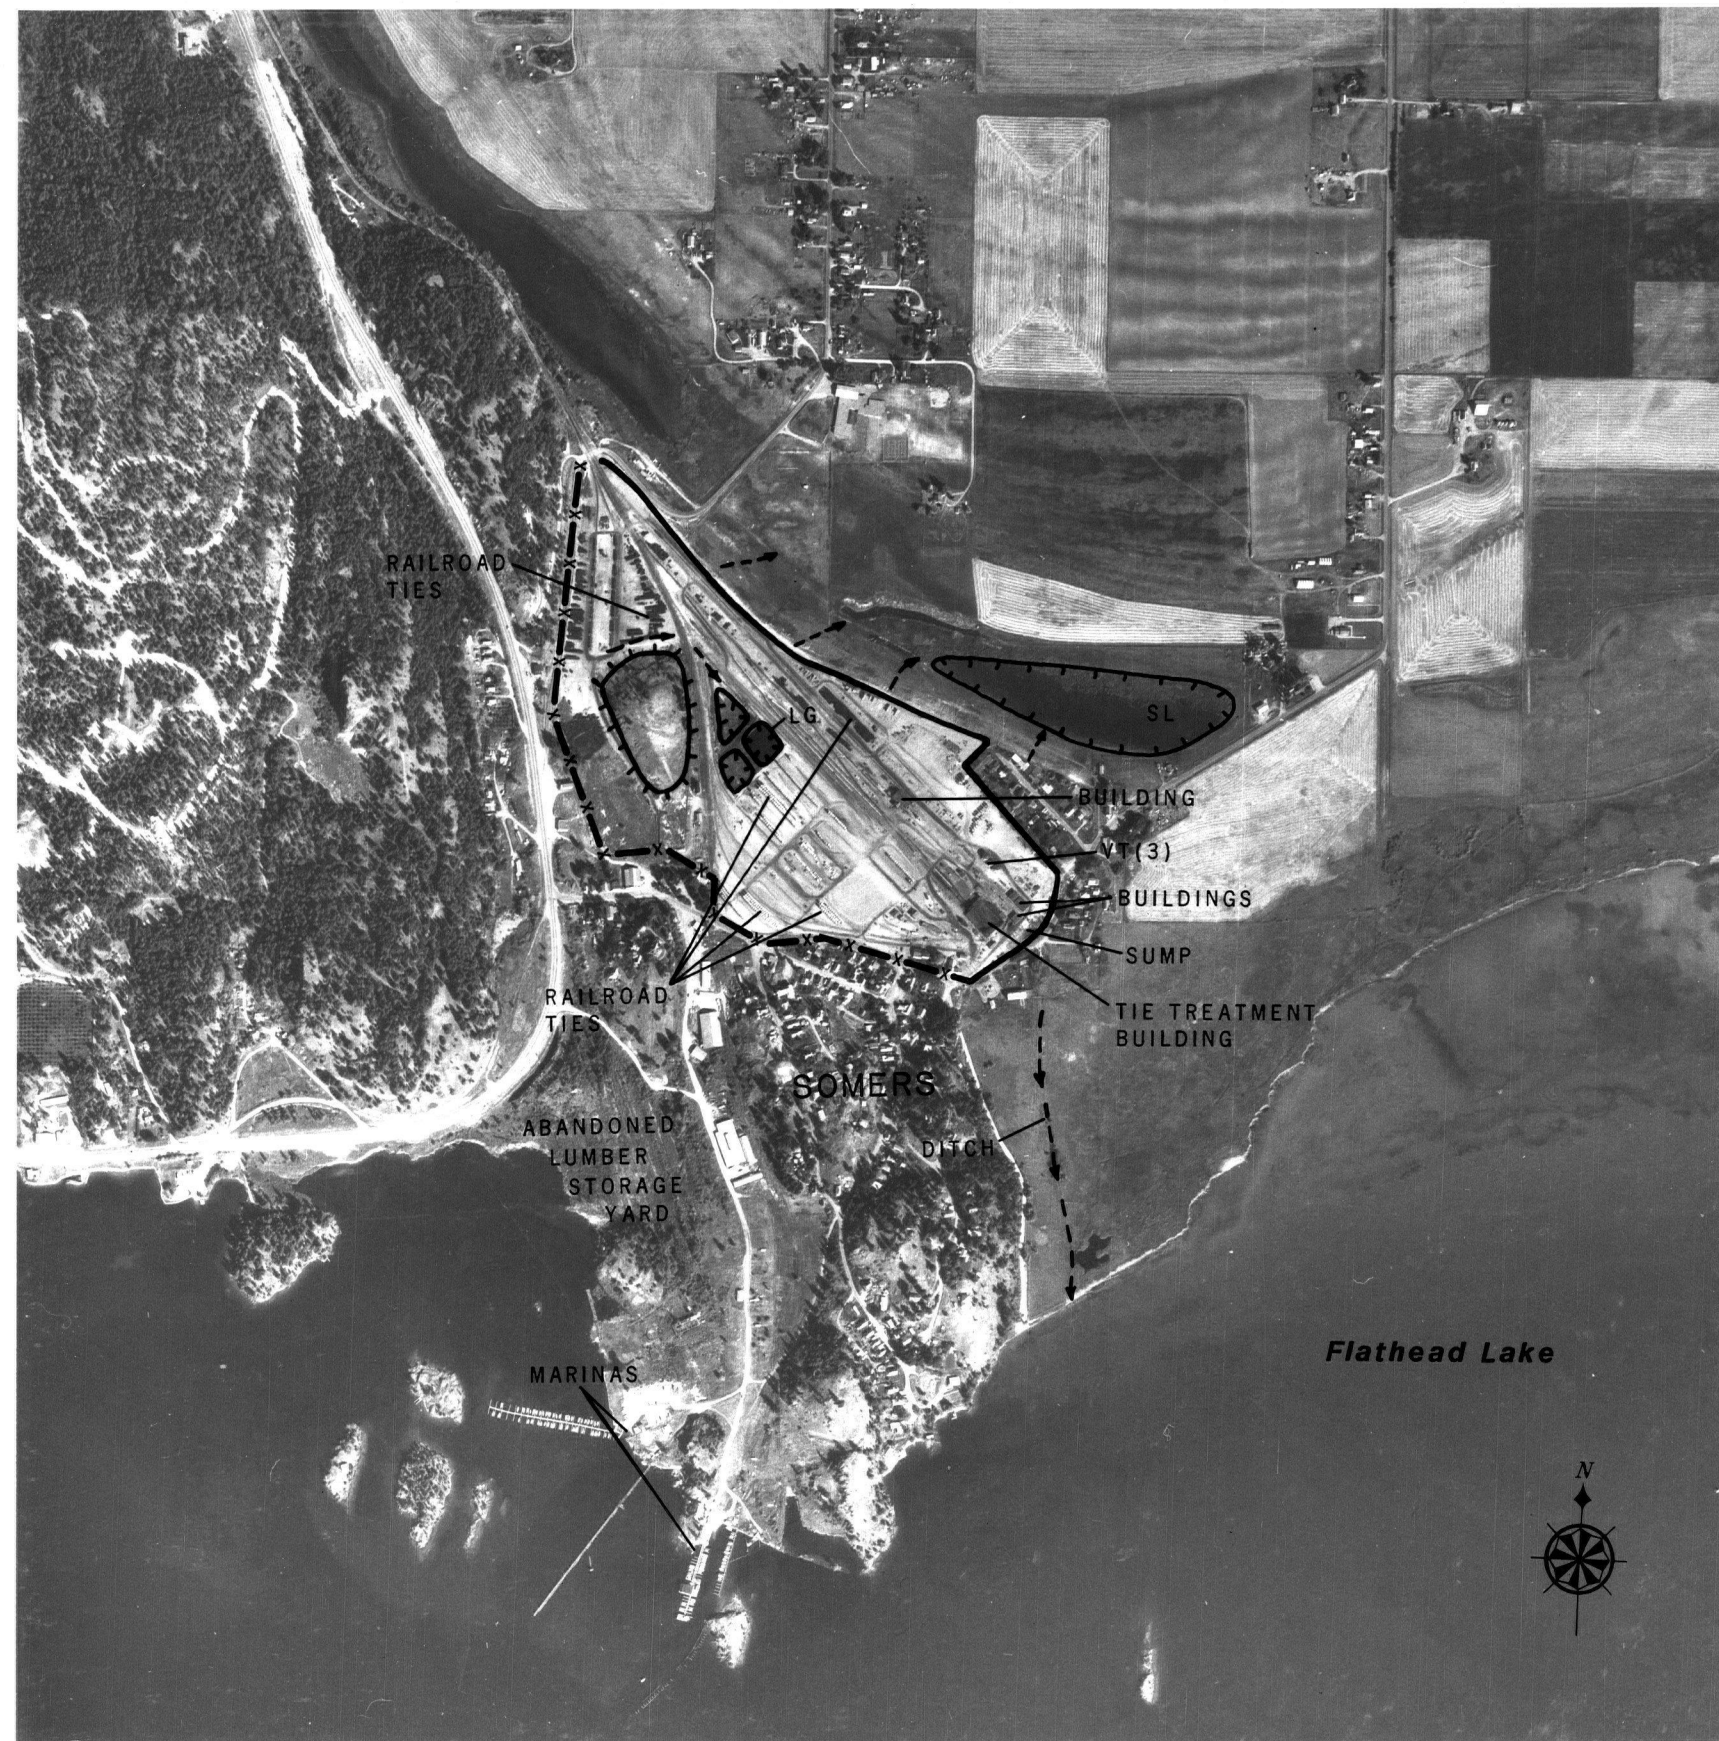
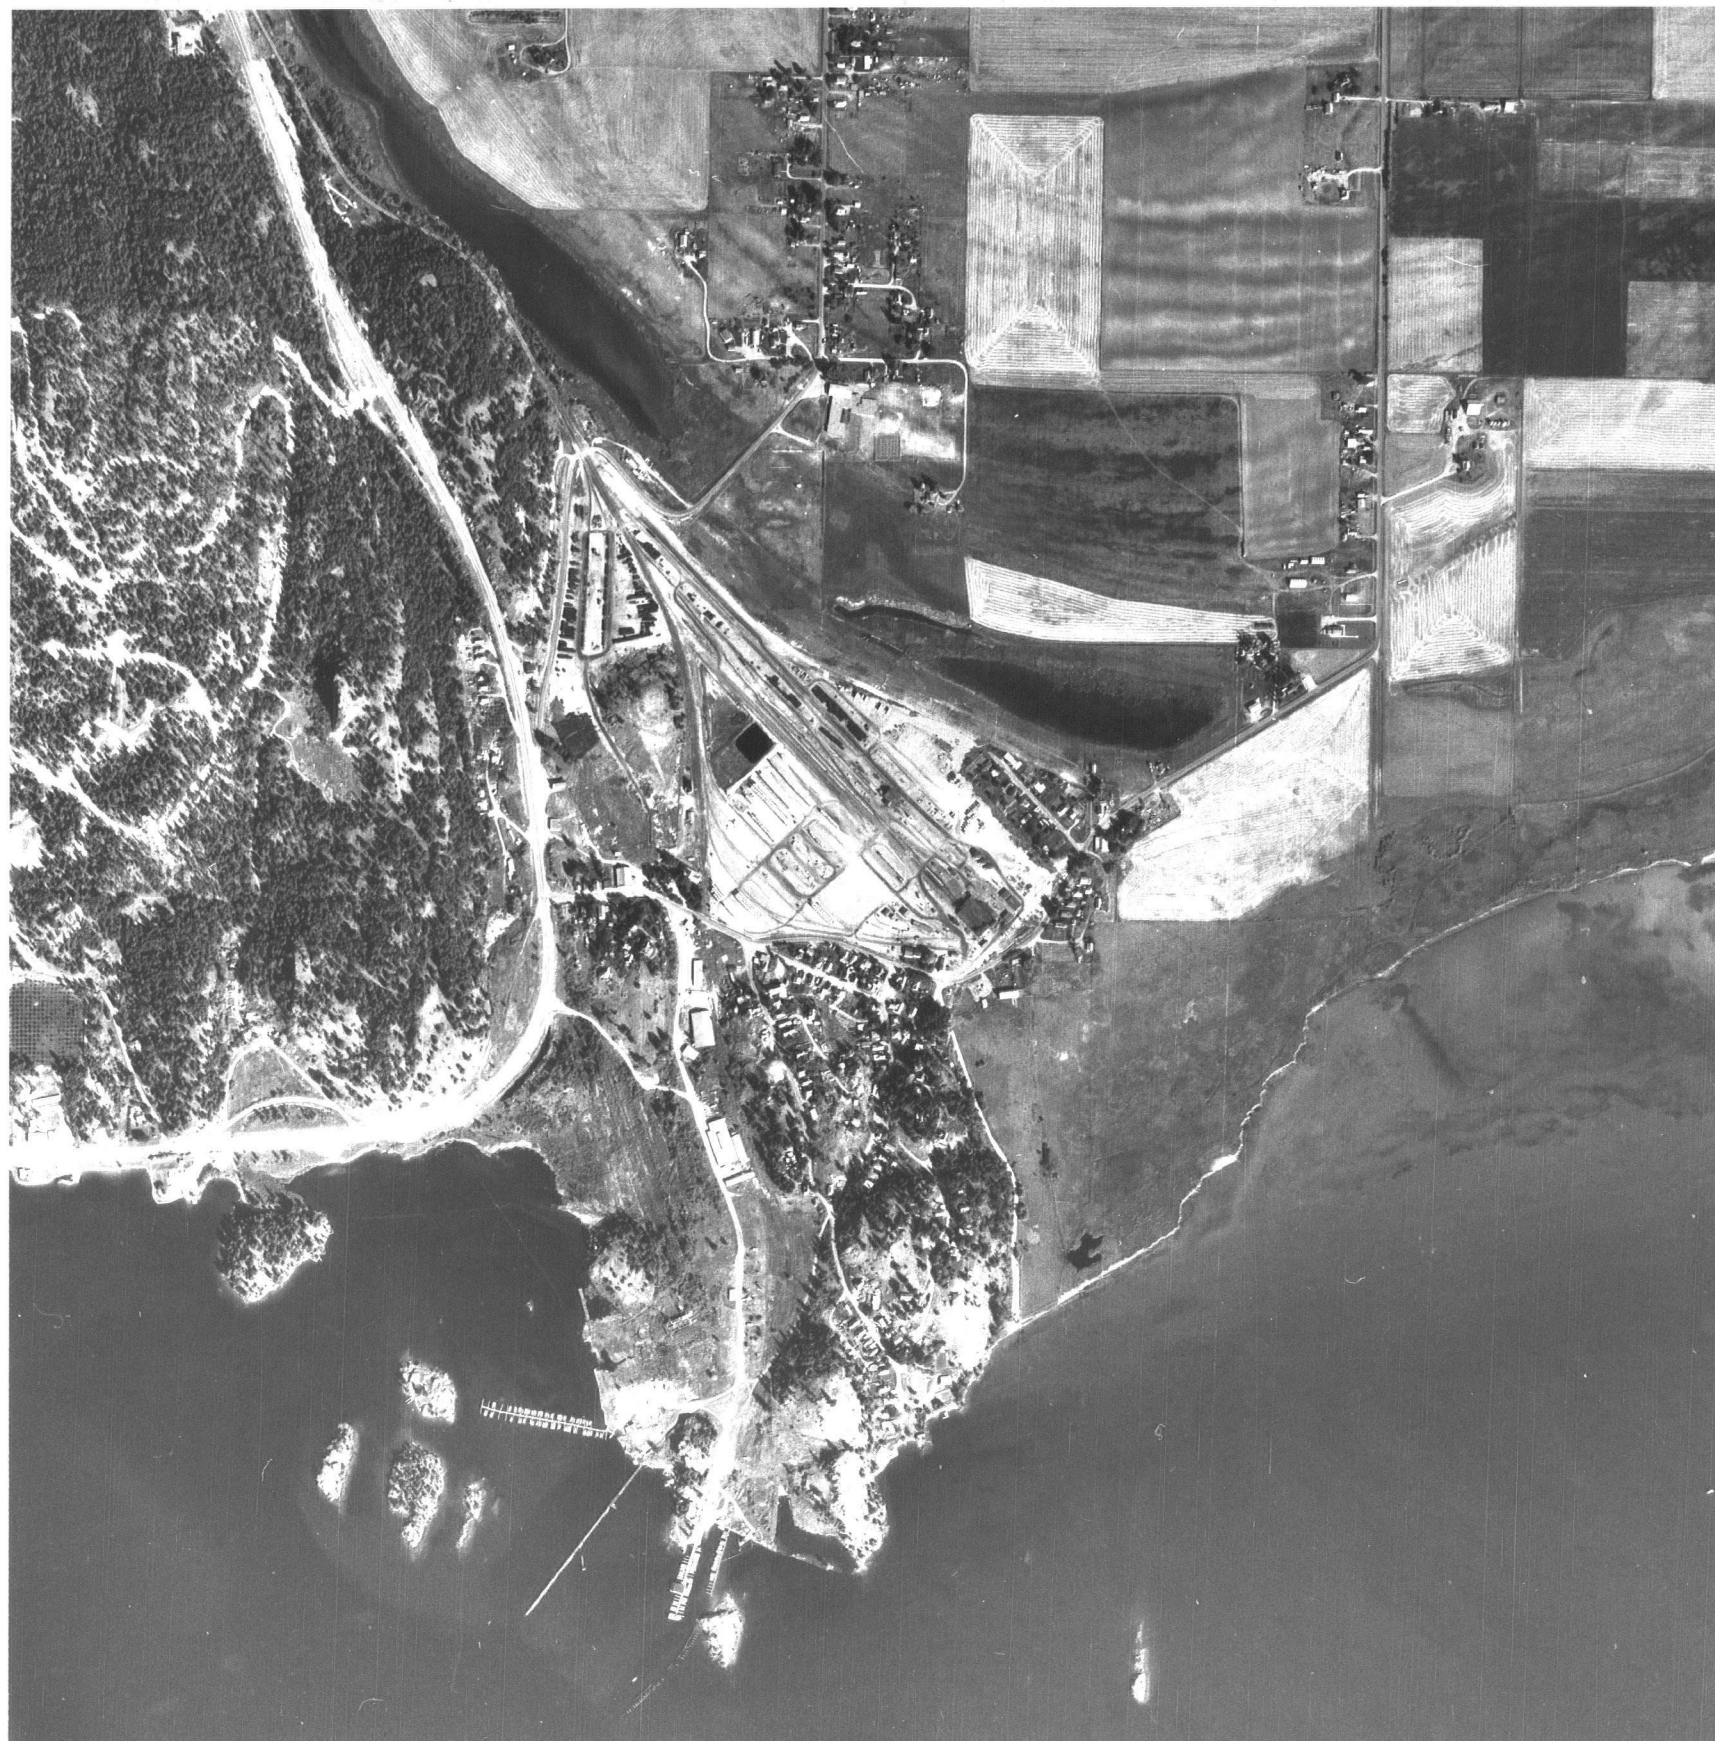
Figure 8. Burlington Northern Railroad, Somers Tie Treatment Plant, September 23, 1979. Approximate scale 1:11,200.

Two marinas are visible on Flathead Lake southwest of the tie treatment facility on the site where a sawmill was observed in the 1937, 1946, and 1954 photographs (Figures 3-5).

The surface drainage patterns remain unchanged over the study area. There are no discernable indications of vegetation stress at this facility.
